**O & M INSPECTION REPORT
FOR NAVIGATION AND SHORE PROTECTION PROJECTS**

1. Project Name: Auasi SBH
2. Date of Inspection: April 12, 2002
3. Inspection Personnel:

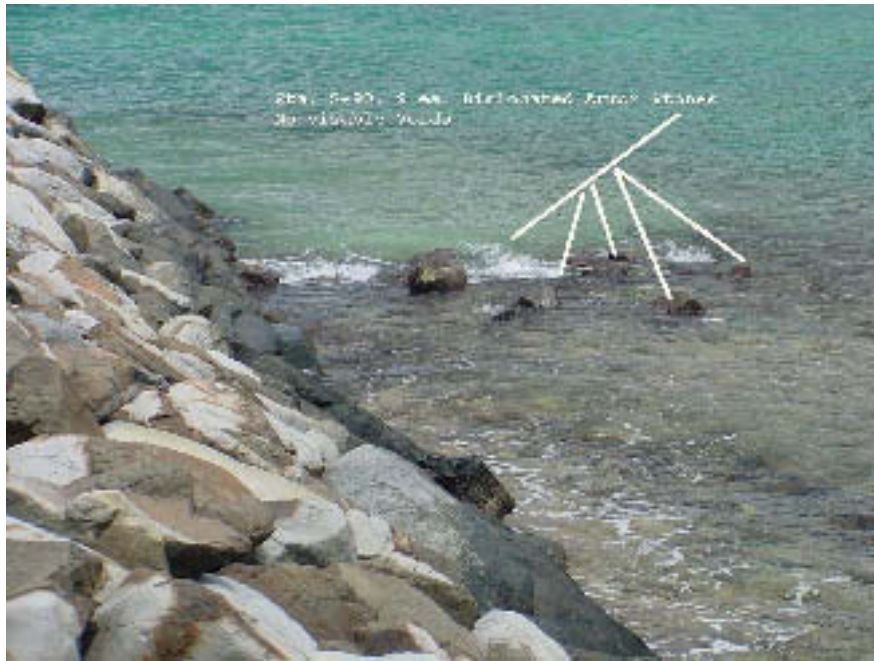
- e. Sta. 2+90, HS, loss of contact @ toe armor stones.

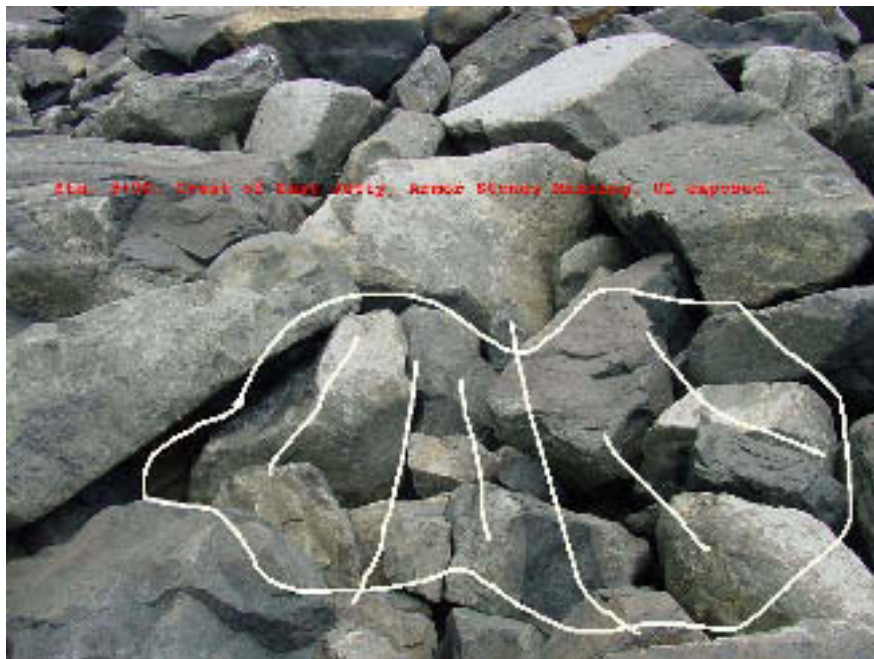
- g. Sta. 3+00, Crest, Monitor dislodged armor stones, underlayer exposed.

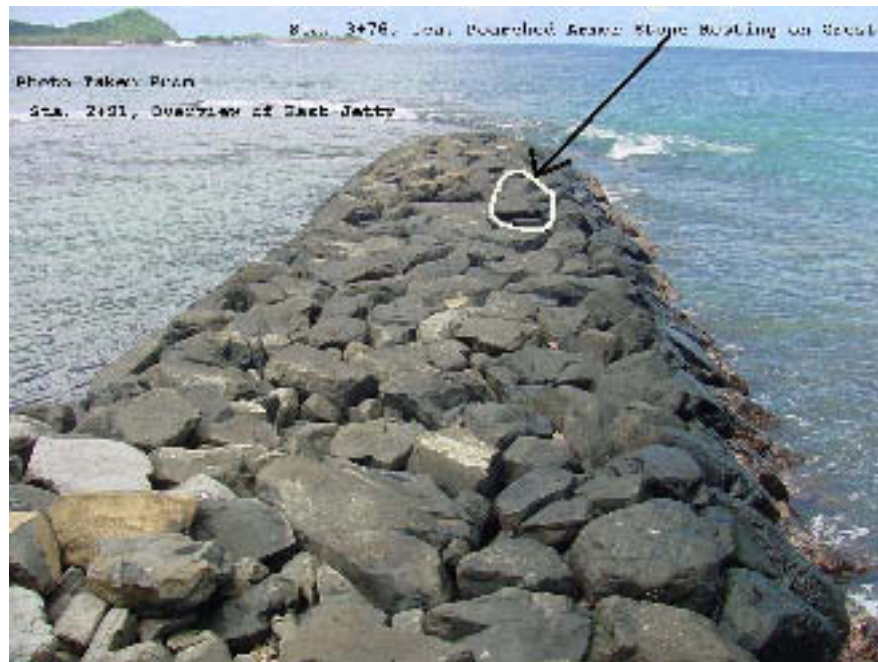
h. Sta. 3+78, Crest, perched armor stone resting on crest.

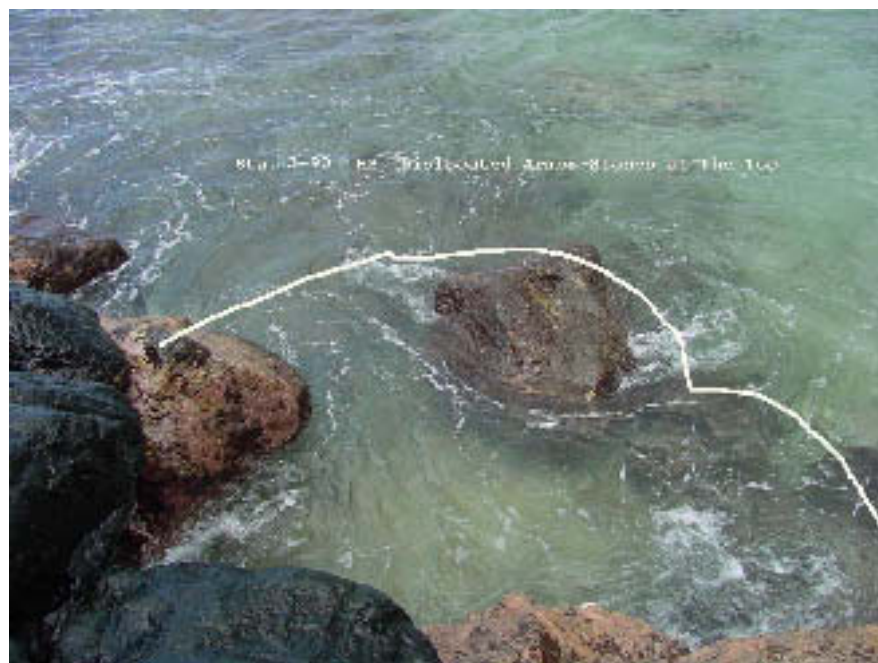
i. Sta. 3+90, Head, Monitor dislodged toe armor stones.

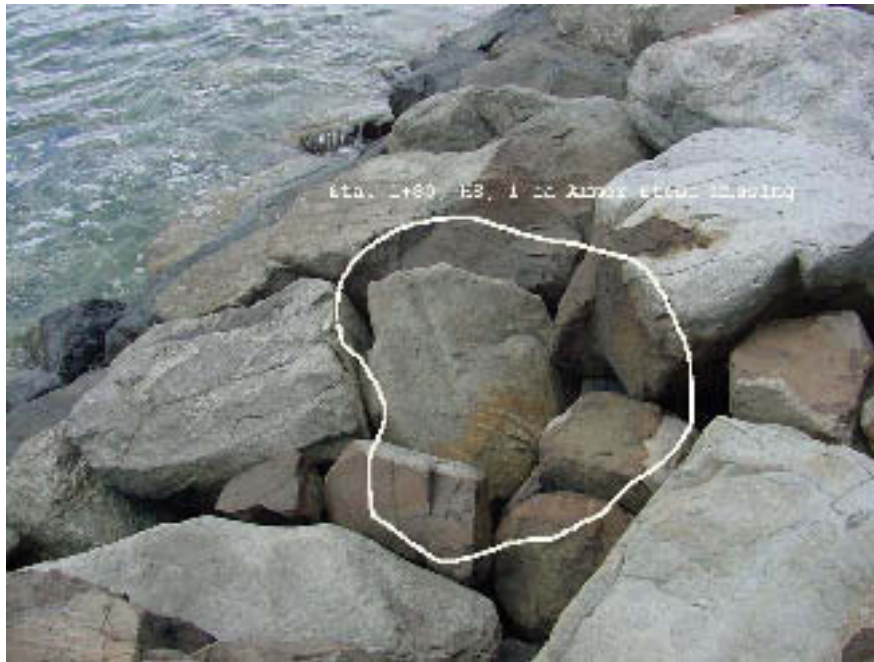
- c. Sta. 1+80, OS, sideslope depression.
- d. Sta. 1+90, OS, sideslope 1 split armor stone.

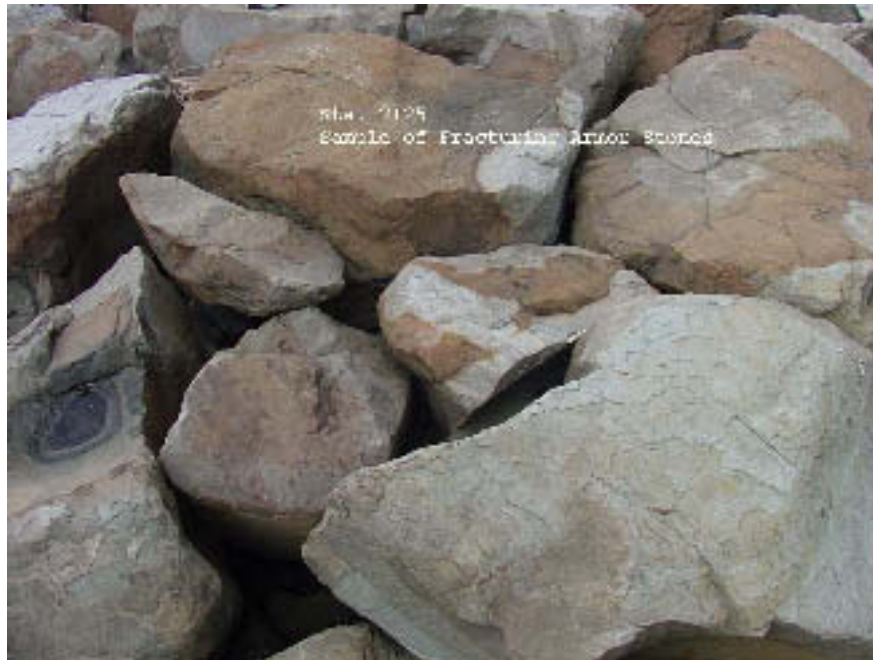
e. Sta. 2+25, crest, 2 split armor stone, split due to overblasting at the quarry site during quarrying operation.

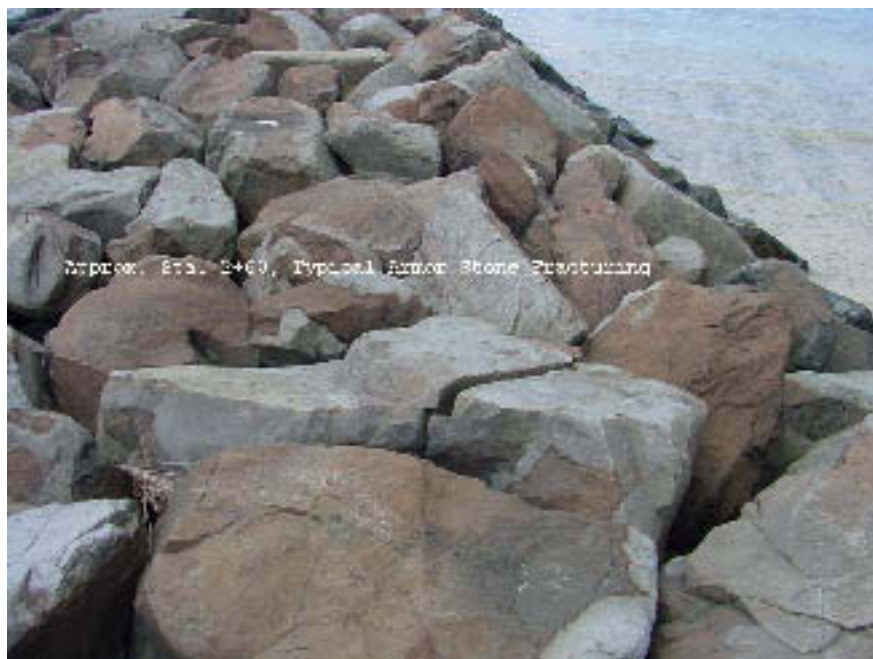
h. Sta. 2+60, HS, 1 split armor stone.

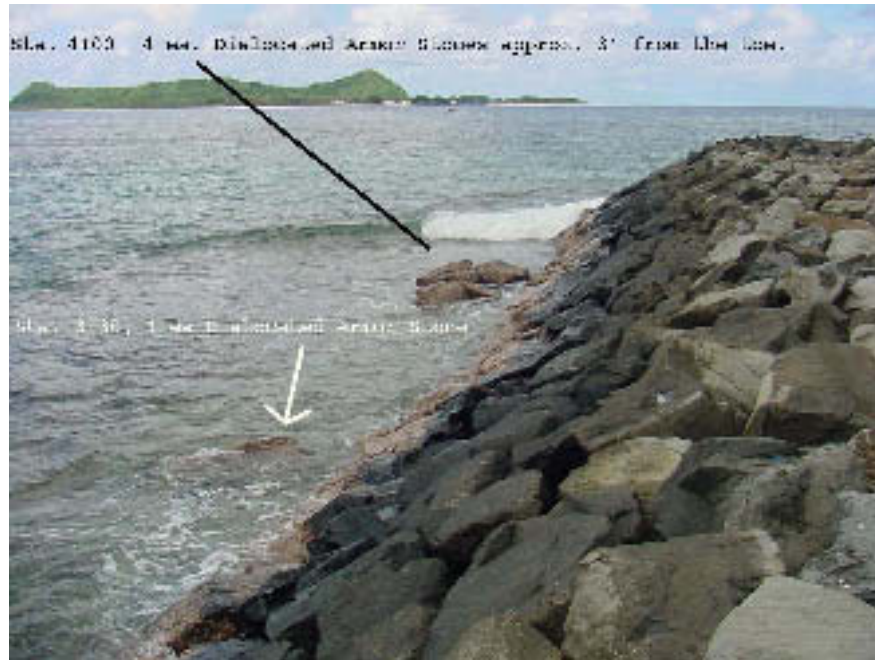
- i. Sta. 3+30, HS, 1 dislodged armor stone at the toe.
- j. Sta. 4+00, HS, 4 armor stones resting 3' from the toe of the structure.

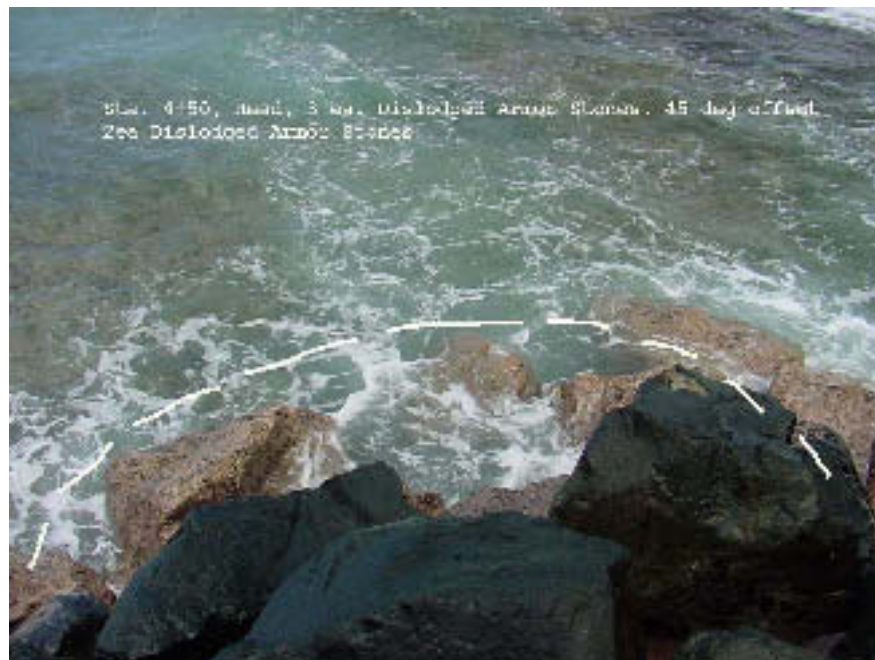
- k. Sta. 4+50, HS, 3 armor stones dislodged 10 degrees offset.

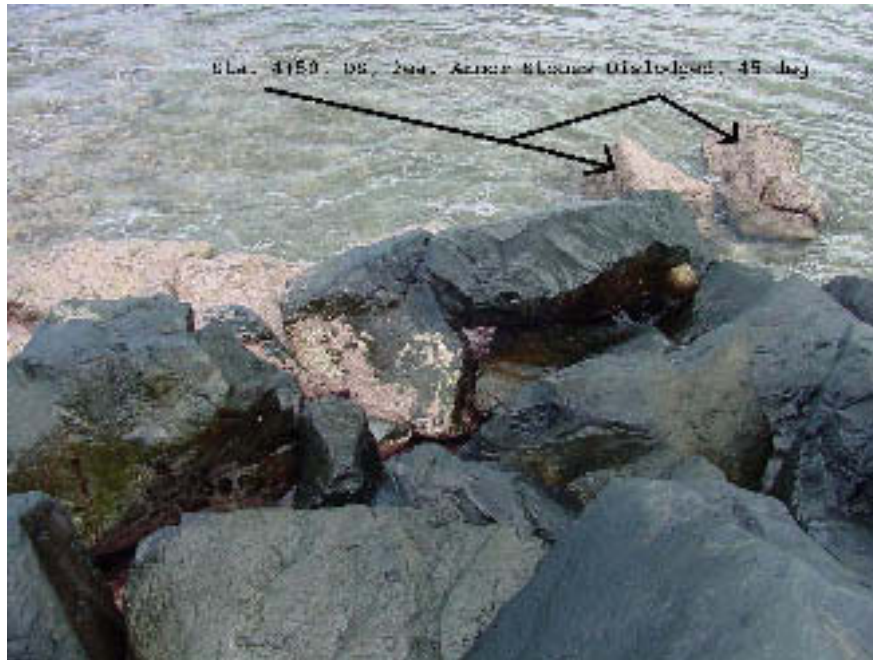
1. Sta. 4+50, OS, 2 armor stones dislodged, 45 degrees offset.
